WARNING

DO NOT BEND HEAT SHRINK TUBING AROUND (i.e. WRAP AROUND) SHIFTER CABLE

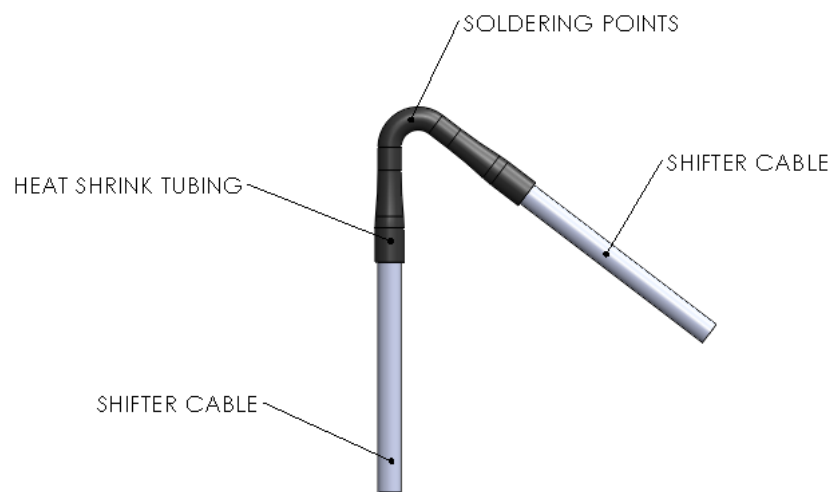
INCORRECT

LOSS OF CONNECTION/SHIFTING COULD RESULT AT SOLDERING POINTS
